## Think You're in The Pink? This May Make You Blue

By James Quarello

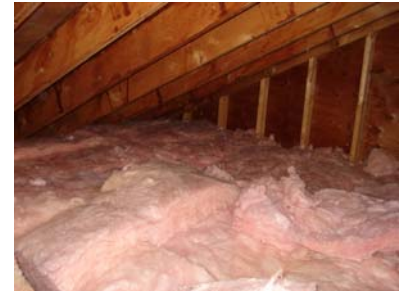
Figure 1: The Pink Stuff

Most everyone is familiar with the pink fiberglass insulation (Figure 1) found in many, many homes. Everyone knows the pink feline character that shows us how this stuff will keep our homes warm and our energy bills reasonable. If only he had an infrared camera, the things he'd see!

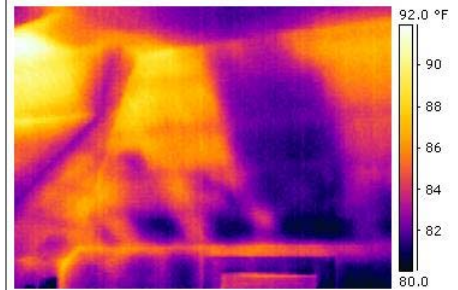
Figure 2

In the first infrared image (Figure 2) which was taken in the summer, this insulated ceiling doesn't look to be insulated at all in some areas. The hot attic air is moving around the insulation, or more accurately the vapor retarder, rendering it ineffective. Air also easily passes through fiberglass (they make filters out of this stuff). Exposed fiberglass attic insulation is subject to convective loops and studies have shown its performance diminishes dramatically as temperature difference increases (winter or summer).

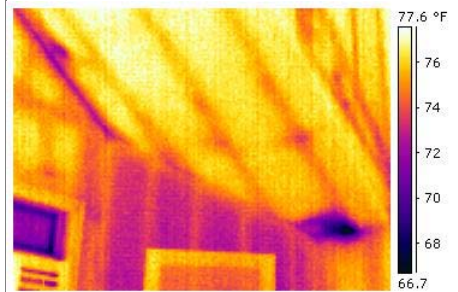
Figure 3

The second infrared image (figure 3) shows a wall section where the studs are actually performing better than the insulation. Notice the wall is cooler (purple) than the studs (orange). This is a 2 x 6 wall with R-19 fiberglass batt insulation. Woods R value is about 1.5 per inch. Which means this R-19 wall is performing at less than R - 8!

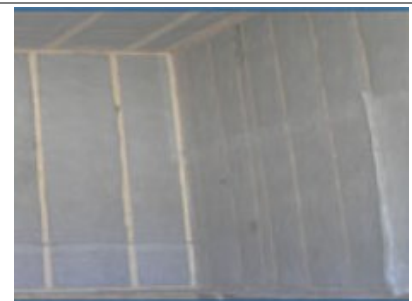
Figure 4: Cellulose

Cellulose insulation (figure 4) on the other hand is not prone to these thermal or convective problems. First it does not require a paper vapor retarder. It can be sprayed or dense packed into wall and ceiling cavities leaving no voids around mechanical penetrations. Cutting and fitting batt fiberglass insulation around electrical boxes, plumbing and heating fixtures results in voids that create airways.

It has a slightly higher R value (3.8 / inch) than high density fiberglass (3.7 / inch). Best of all it is made from recycled materials (newspaper) and uses significantly less energy (750 Btu / lb.) to manufacture than fiberglass (12,000 Btu / lb.) or foam (33,000 – 48,000 Btu / lb.) insulations.

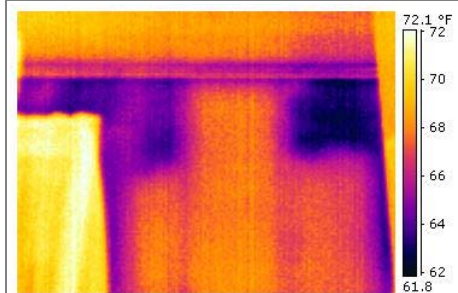
Figure 5

One potential problem with cellulose is in retrofit applications. As can be seen in the last infrared image (Figure 5) these wall cavities were incompletely filled by the installer. Older cellulose in some instances was prone to settling, usually due to a poor installation.

Cellulose today is manufactured to eliminate settling by making the material somewhat “springy”. Further by dense packing it in the wall cavity the material is under slight pressure and can not move. No more settling problems.
